Intel[®] 82801BA I/O Controller Hub 2 (ICH2) and Intel[®] 82801BAM I/O Controller Hub 2 Mobile (ICH2-M)

Specification Update

May 2004

Document Number: 298242-027

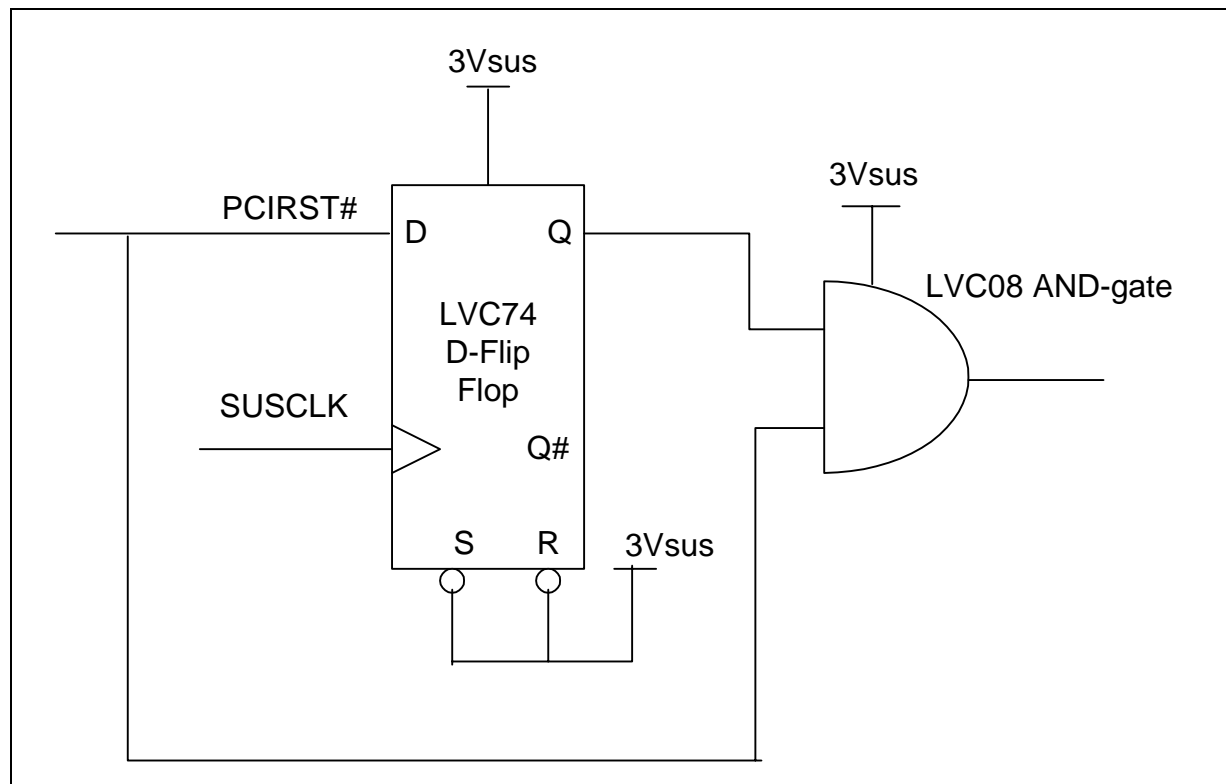
Implication: Some LPC devices may not properly reset resulting in failure of the system to boot or resume from a sleep state.

Workaround: Use any one of these three workarounds:

- 1) Delay PCIRST# by 1 susclk using a D-flop and an AND gate to the LPC devices.
