Intel[®] 82801BA I/O Controller Hub 2 (ICH2) and Intel[®] 82801BAM I/O Controller Hub 2 Mobile (ICH2-M)

Specification Update

May 2004

Document Number: 298242-027

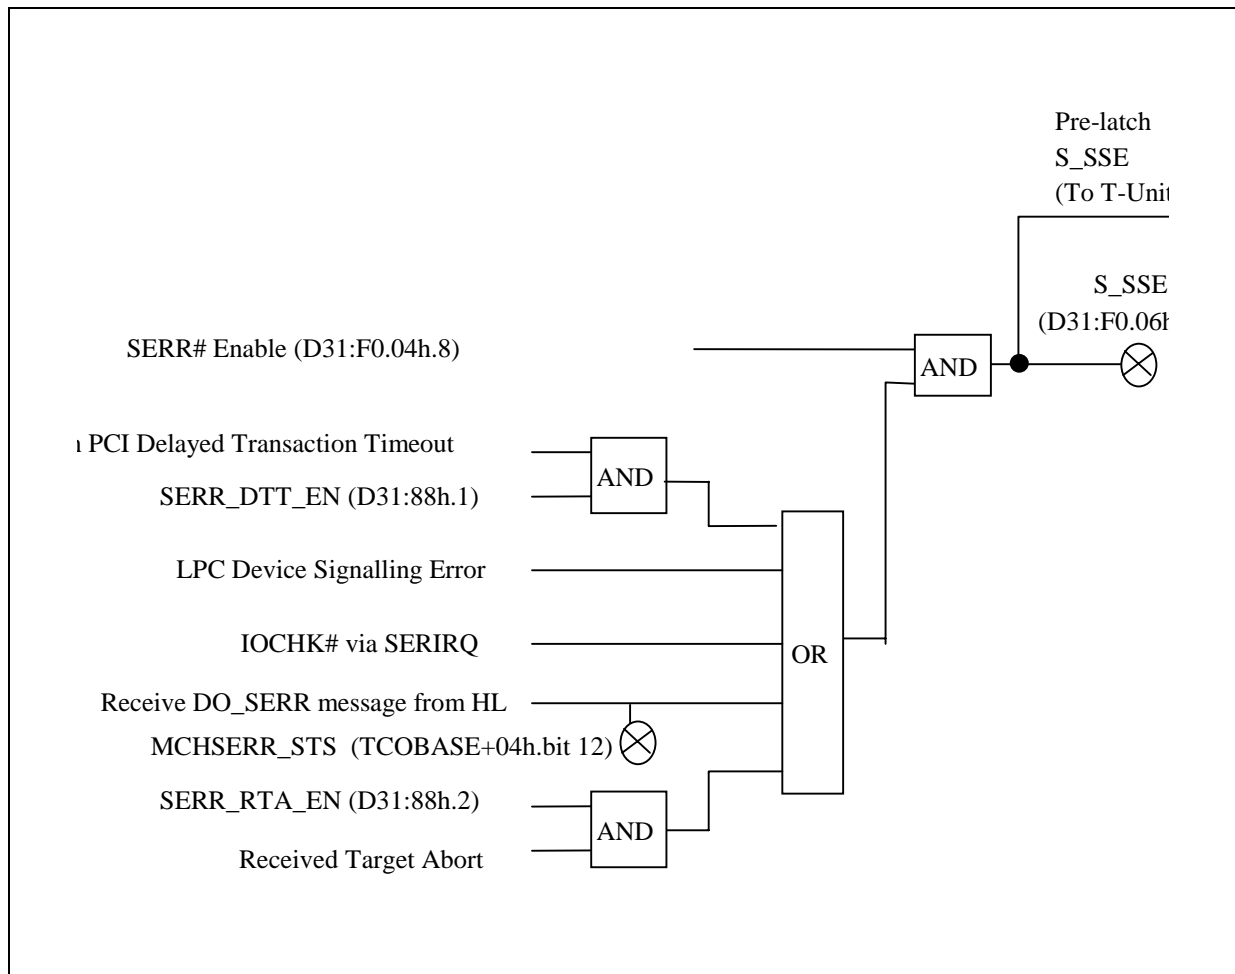
16. Corrections to Section 5.1.4 SERR# Functionality

The following note is added just below Figure 5-3: “D30:F0;1Eh:[14] (SEC_STS:[SSE]) is only set when SERR# is detected asserted. Additionally, Figure 5-2, *Secondary Status Register Error Reporting Logic*, is replaced with the figure below:

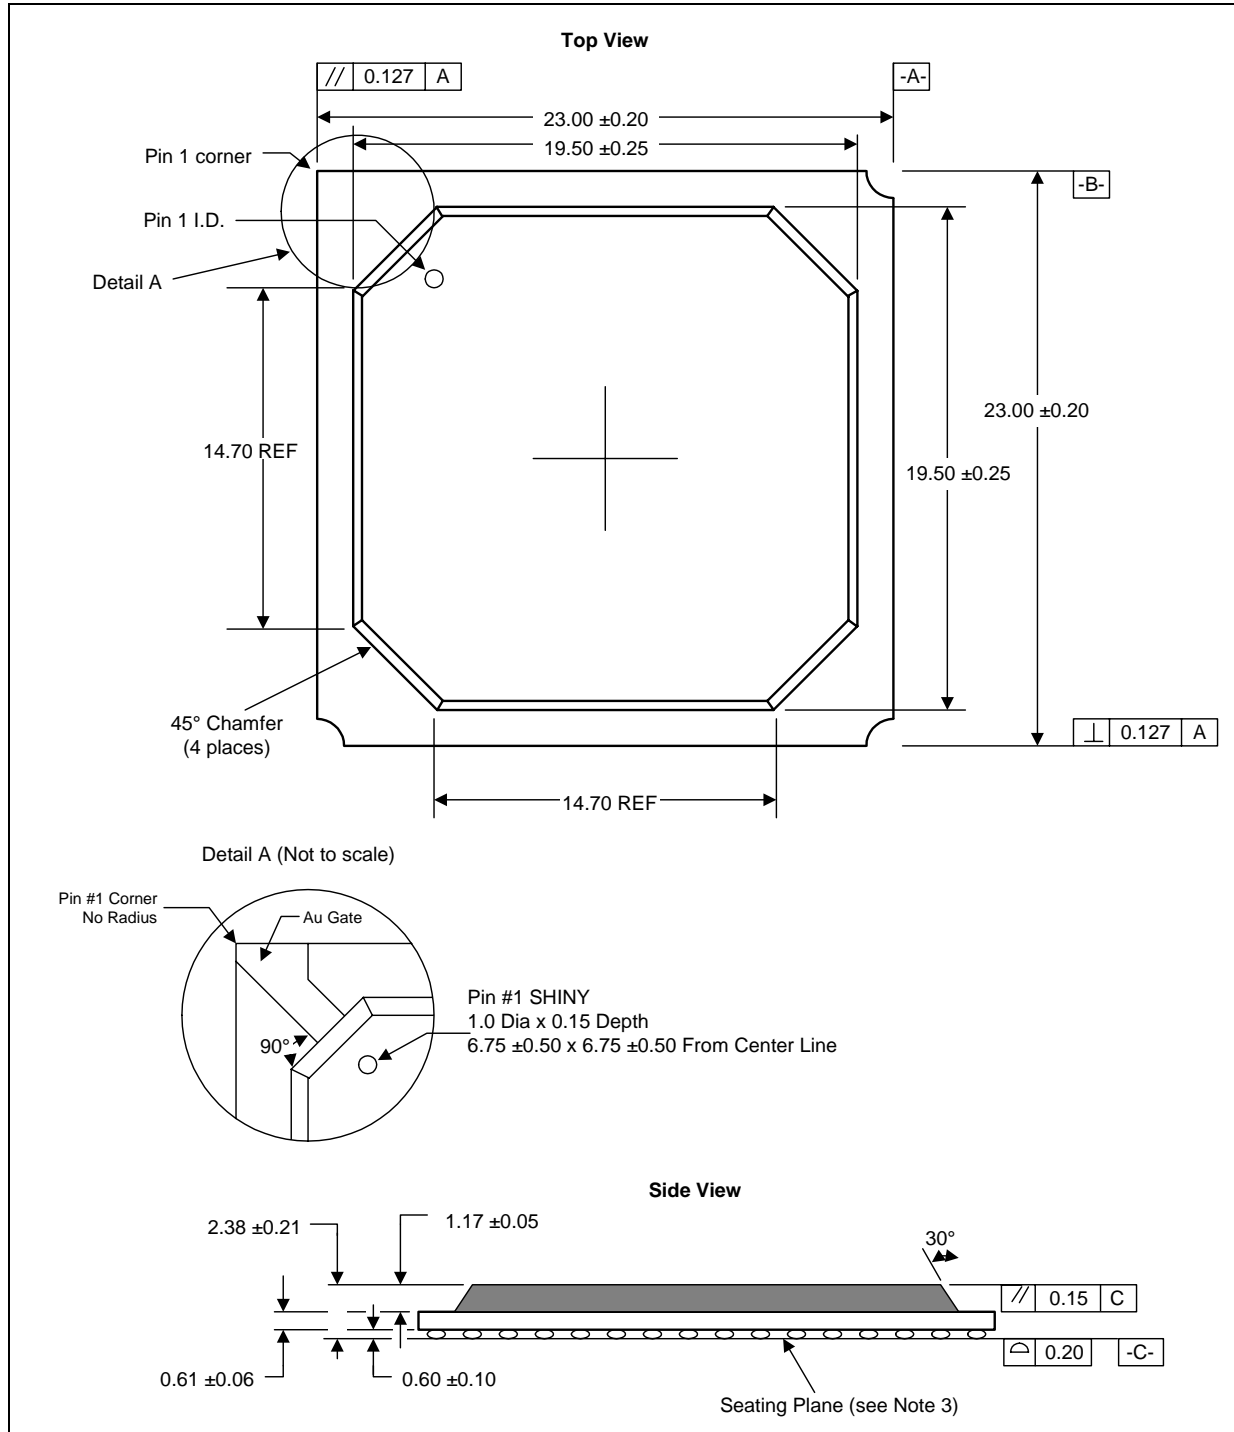
28. Change to Package Information

Figure 15-3 is replaced with the figure below.
