# Intel<sup>®</sup> 631xESB/632xESB I/O Controller Hub (ESB2)

Specification Update

October 2009

*Document Number: 313075-007*

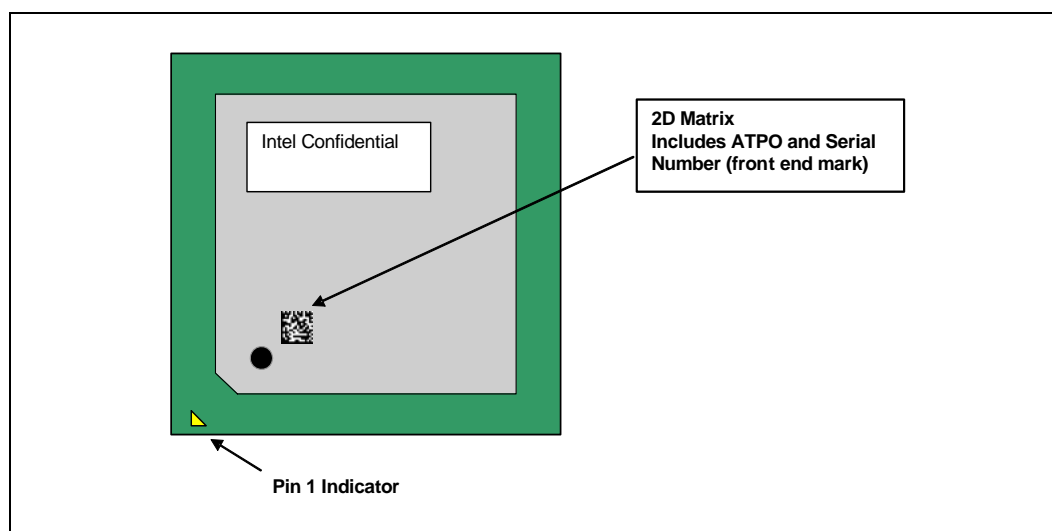
Figure 1. Top-Side Marking Example

Stepping	S-Spec	SKU	Top Marking	Notes
A-1, leaded	QJ89	Intel® 6321ESB I/O Controller Hub	NQ80003ES2	Sample
A-1, Pb free	QJ90	Intel® 6321ESB I/O Controller Hub	QG80003ES2	Sample
A-1, leaded	QJ93	Intel® 6311ESB I/O Controller Hub	NQ80003ES2	Sample
A-1, Pb free	QJ94	Intel® 6311ESB I/O Controller Hub	QG80003ES2	Sample
A-1, leaded	SL97P	Intel® 6321ESB I/O Controller Hub	NQ80003ES2	Production
A-1, Pb free	SL97Q	Intel® 6321ESB I/O Controller Hub	QG80003ES2	Production
A-1, leaded	SL97M	Intel® 6311ESB I/O Controller Hub	NQ80003ES2	Production
A-1, Pb free	SL97N	Intel® 6311ESB I/O Controller Hub	QG80003ES2	Production
