## HP Consumer Support

# Motherboard Specifications, FW37T (Oslo)

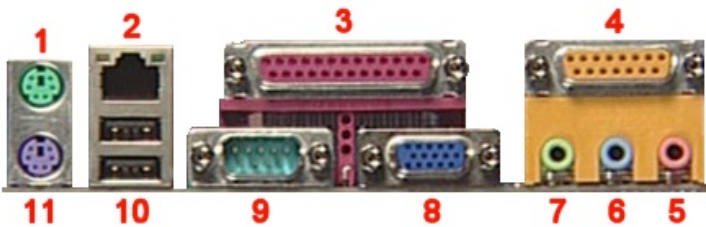
**1 - Mouse**

**2 - RJ45**

**3 - Parallel**

**4 - Gameport**

**5 - Microphone**

**6 - Line-out**

**7 - Line-in**

**8 - VGA**

**9 - Serial**

**10 - USB**

**11 - Keyboard**
